MIDDLESEX RESERVOIR DAM

PHASE I INSPECTION REPORT

NATIONAL DAM SAFETY PROGRAM

NJ 00377

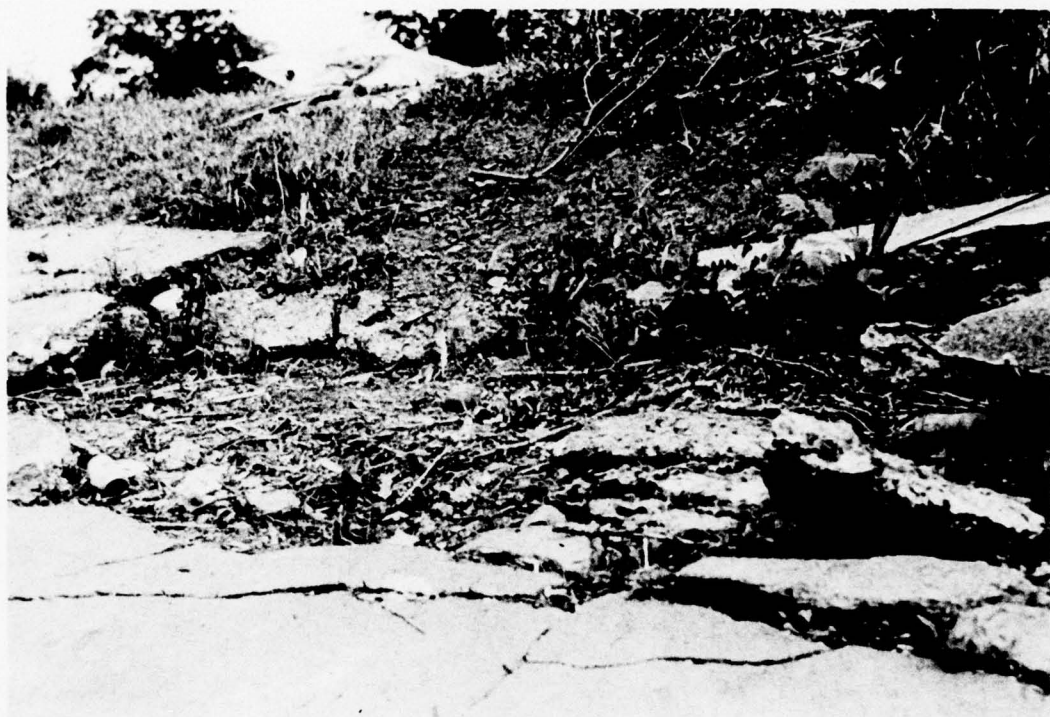
PHOTO 9

Disintegration and settlement of the concrete slope protection is especially severe 50 feet from the spillway, as shown in Photo 9. Near the right abutment a groundhog burrow was observed that extended under the concrete pavement. Numerous small trees and brush are present on the embankment crest and slopes.

(5) The badly deteriorated and failed slope paving on the embankment upstream slope should be replaced or covered with rip-rap, or an alternate means of protection should be developed to protect the embankment slope. The corrective solution for this problem should be engineered.
